Observation of abutment tooth cementum and coping margin

A Sugita.¹, S Endo.¹, E Nagai.^{1,2}, N Tsukimura.^{1,2}, H Saito.¹, M Morokuma.¹, N Suzuki.¹,
D Akita.¹ and T Ishigami.^{1,2}

¹Department of Partial Denture Prosthodontics, Nihon University School of Dentistry

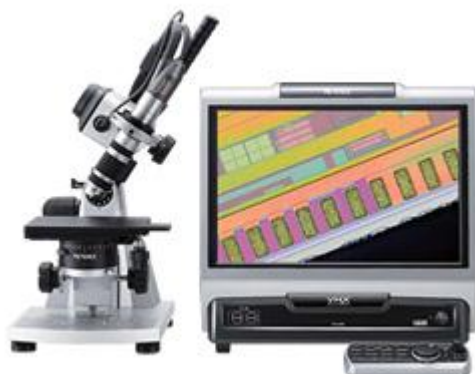
Fig.2 microscope

10 extracted teeth with the margin of the coping were observed with laser microscope (VHX-1000, KEYENCE, Tokyo, Japan). (fig2)

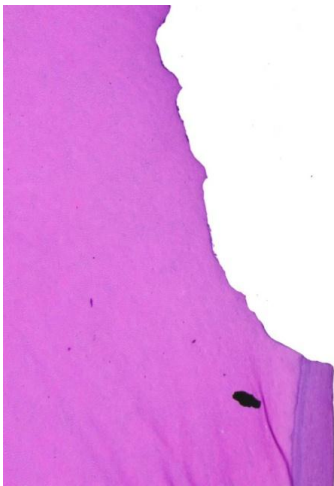
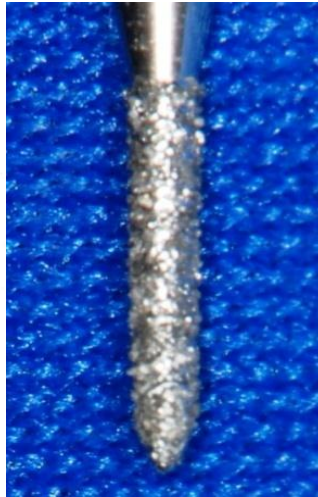
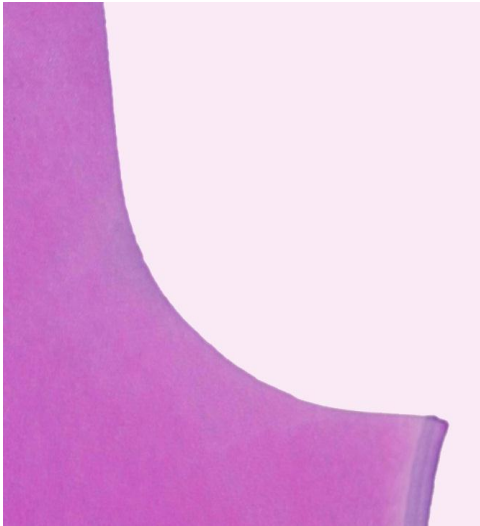
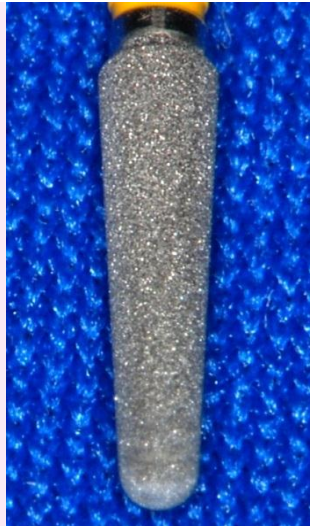
Fig.3

Showing the Figure 3 by using 106RD or SF106RD and preparation of root.

Forming surface shows the serrate, and the marginal types was chamfer. The coping margin place on c Fig.1

ementum .There were no chipping and cracking of cementum. It was smooth surface formation of SF106RD from 106RD better.

1. As the result of this study, for the observation of after preparation of root surface. It is less likely that the cementum will cause chipping by using a diamond point. (fig3) On the other hand root of SRP seems to have cracks and exfoliation of cementum after preparation of root surface. (fig4)

It is concluded that prepared cementum of root surface with diamond point has little influence on root surface. On the other hand, chipping or cracking of cementum was observed in SRP using an ultrasonic scaler. This crack is because the abundance of sharp fiber in cervical tooth cementum, prom to cracking along this fiber. Base upon the results of this study, the coping margin place on cementum, it may be caused by non-conforming margin by SRP.

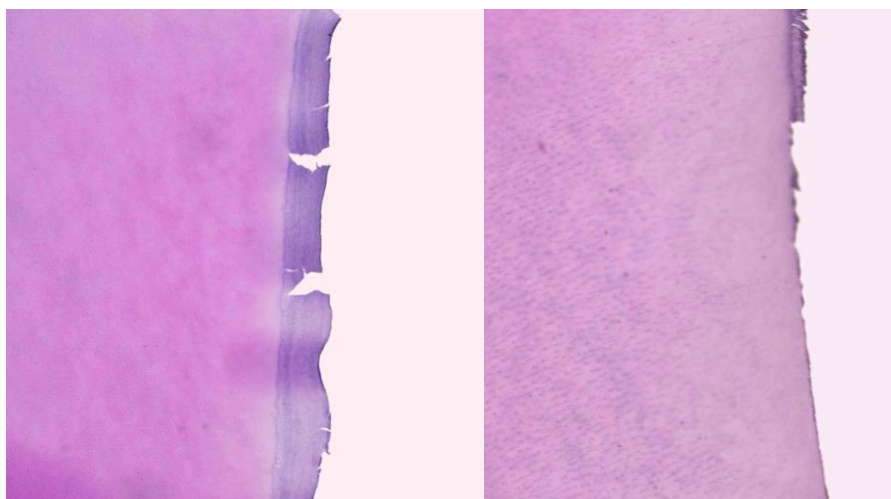
Fig.4

SRP using a hand scaler is found most cementum had been removed from SRP using a ultrasonic scaler.

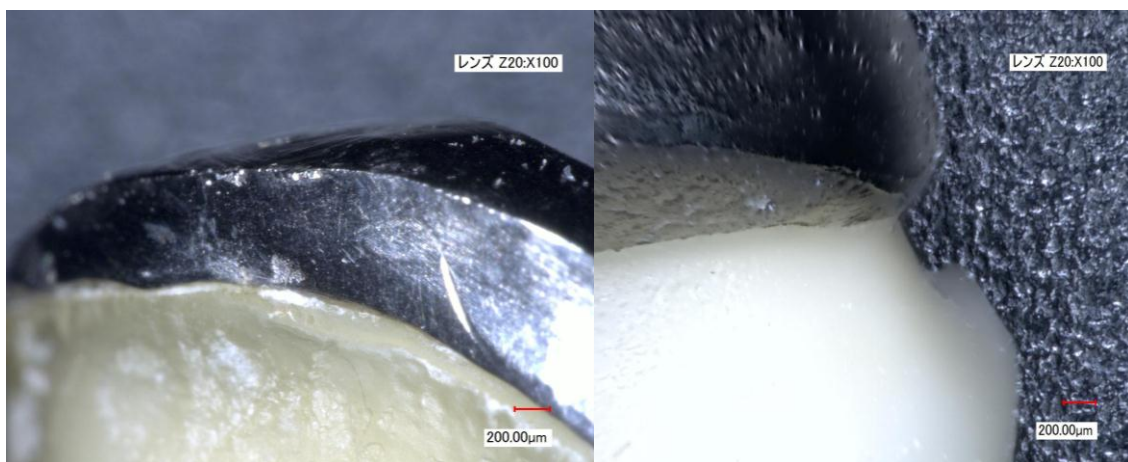
Fig.5

2. Margin was seen in 8 of 10 non-conforming to these samples. And they were observed around the coping margin at a magnification 100. (fig5)

Based upon the results of this study, it is concluded that prepared cementaum of root surface with diamond point has little influence on root surface. Many of the extracted teeth with the margin of the coping, There are steps between the coping and the root surface, non-conforming margin was observed.
