A case report of same-day denture repair using magnetic attachments

Abstract

We report clinical uses of magnetic attachments for the repair of dentures and retainers on the same day.

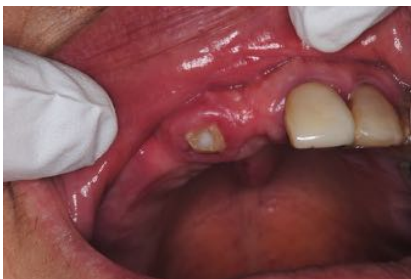
Clinical History: The patient, a 66-year-old female, complained of masticatory dysfunction. The patient had a partially edentulous maxilla and mandible (Eichner B3). At the initial examination, a fixed bridge on #7, 8, and 9 as abutment teeth for removable partial denture was detached, and #7 was found to have been damaged by caries. The patient was dissatisfied with the dynamic stability and retention of the denture (Fig.1–3).

Fig.1 Intraoral view after amputation of bridge

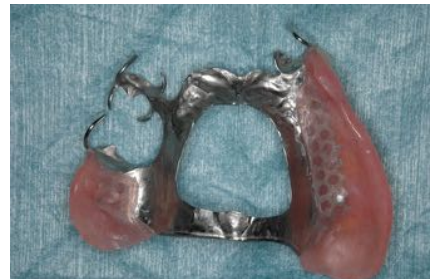
Fig.3 Previous denture

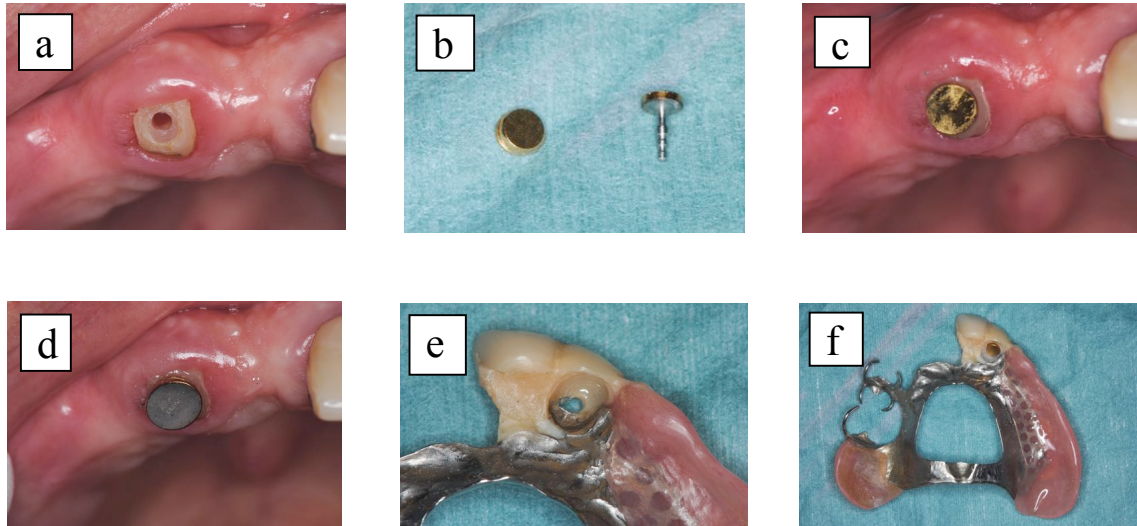
Fig.4 Treatment procedure of the magnetic attachment (a. preparation of root, b. magnetic attachment, c. seating of the keeper, and d–f. seating of the magnetic assembly)

Treatment Procedure: The fixed bridge was cut off between #8 and #9, and the magnetic attachments that act as retention elements were applied to the remaining radicular tooth of #7. MAGFIT® RKR (AICHI STEEL, Japan) magnetic attachments were used in this case. Keepers of the magnetic attachment were fixed with adhesive resin cement on the abutment teeth (G-CEM LinkAce, GC, Japan). Then, the magnetic assembly was attached to an additional tooth (Zen Opal Shell, GC, Japan) by denture repair (Fig.4). As a result, the patient's complaints of functional dissatisfaction were resolved (Fig.5).

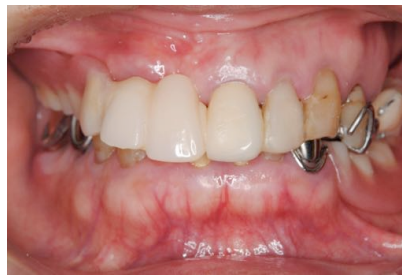
Fig.5 Intraoral view after prosthetic treatment

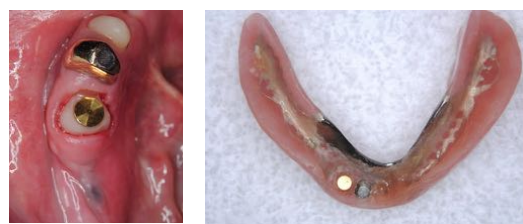
Fig.7 Intraoral view and denture after prosthetic treatment

Treatment Procedure: Magnetic attachment (MAGFIT[®] RKR, AICHI STEEL) that act as retention elements was applied to the remaining radicular of tooth #22 (Fig.7). As a result, the patient's complaints of functional dissatisfaction were resolved.

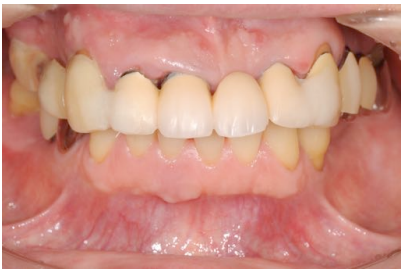
Clinical History: The patient, a 65-year-old male, had a partially edentulous mandible (Eichner B1: missing mandibular second premolar and first molar teeth) with the chief complaint of masticatory dysfunction. All maxillary prostheses had failed, with a marginal discrepancy and caries damage (Fig.8 and 9).

Fig.8 Intraoral view at the initial examination

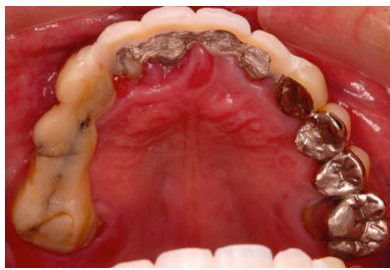
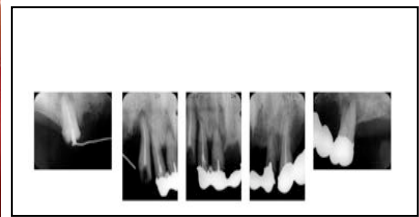
Fig.9 Dental radiographs at the initial examination

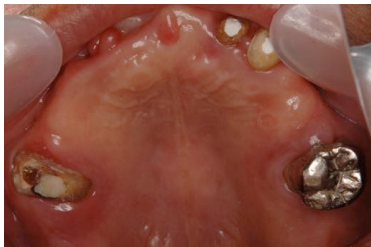
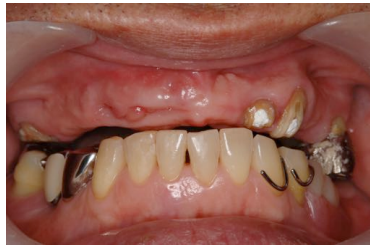
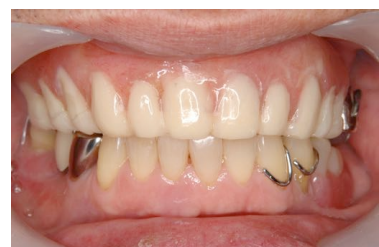
Fig.10 Intraoral view with an immediate denture

Treatment Procedure: First, the prostheses with marginal discrepancies were removed, and the #6, 7, and 8 teeth were extracted due to severe caries and periodontitis. Then, an immediate denture in the maxilla was set on a portion of the edentulous area(Fig.10). The magnetic attachments that act as retention elements were applied to the remaining radicular teeth (#3, 10, and 11). GIGAUSS D400[®] (#10 and #11 teeth) and GIGAUSS D1000[®] (#3 tooth) (GC, Japan) magnetic attachments were used in this case. Keepers of the magnetic attachment were fixed with adhesive resin cement on the abutment teeth (Multilink[®] Automix, Ivoclar Vivadent, Liechtenstein) (Fig.11). As a result, the patient's complaints of functional dissatisfaction were resolved immediately.

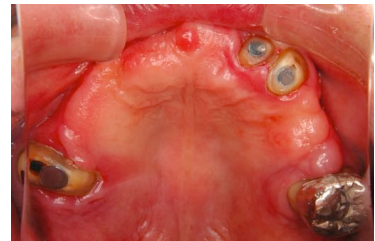
Fig.11 Seating of keepers on the abutment teeth
