Denture repair with the application of a magnetic attachment to the inner crown of a telescopic crown: A 3-year follow-up case

Department of Comprehensive Dentistry, Tohoku University Hospital

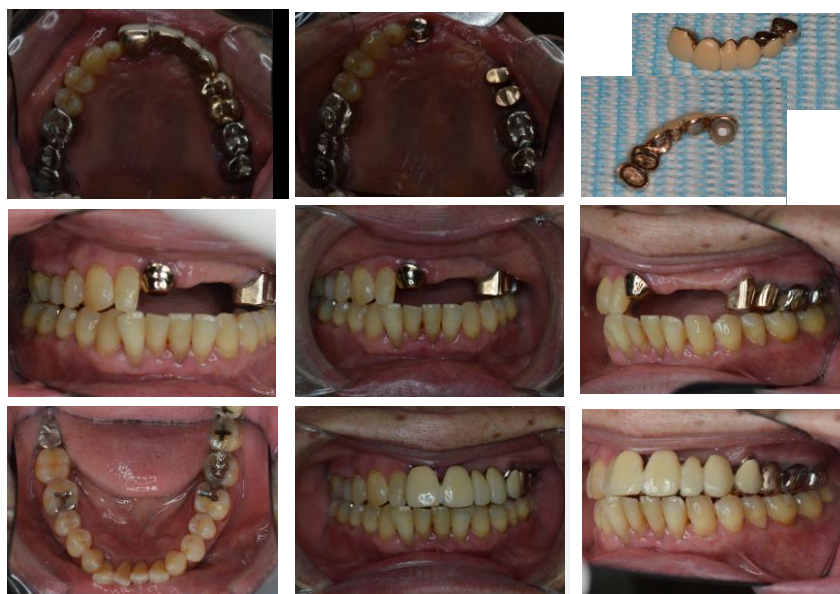
periodontitis occurred on the maxillary right central incisor that was one of the abutment teeth. After the inner crown of the tooth was removed, a root canal treatment was performed. Following prosthetic treatment, a magno-telescopic crown (MT crown) was fabricated for the maxillary right central incisor and adapted to the corresponding outer crown. In July 2015, the dental prosthesis was repaired using a magnetic attachment (GIGAUSS C 300, GC, Japan) for the existing outer crown (Fig.1).

Fig.1 Intraoral view and the denture at the denture repair (2015.7.24)³⁾

Specifically, as a method of manufacturing the MT crown, the root canal part of the maxillary right central incisor tooth was waxed according to the metal core production, and the approximate shape was prepared using a room temperature polymerized resin as a pattern from the cervical portion to the crown. Then, using the denture temporarily borrowed from the patient, the wax pattern of the MT crown was fabricated while directly conforming to the inner surface of the outer crown. At the same time, a space for mounting the magnetic attachment inside the outer crown was secured. The keeper was manufactured by the cast-joining method. The magnetic attachment was attached at the next medical treatment after the patient wore the MT crown. At that time, the facing hard resin of the outer crown was removed, and it was newly built up.

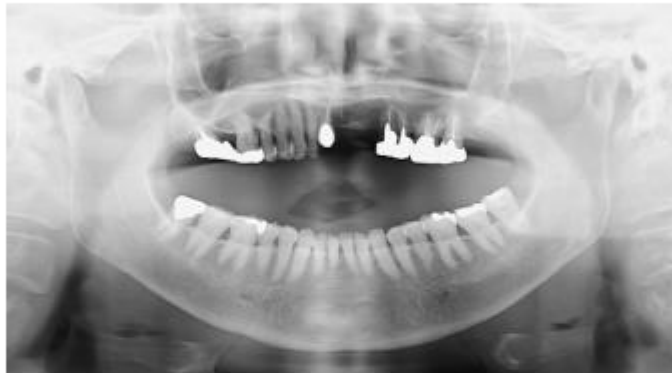
Denture repair was completed in July 2015. Thereafter, this case shifted to one of maintenance and recall. In the meantime, as a restoration, the bridge of the maxillary right molar section was remade due to desorption. Panoramic X-ray photographs taken three years and two months after the denture repair are shown in Figure 2, and Figure 3 shows the periodontal pocket of the abutment tooth at the time of wearing the denture in December 2000, repairing the denture, and three years after the repair of the denture. While continuing to use not only the maxillary right central incisor tooth with the MT crown attached but also the maxillary left first premolar tooth and the maxillary left second premolar tooth, the periodontal tissue has been generally well preserved. In addition, there was no detachment of the magnetic attachment or the other inner crown by the room temperature-polymerized resin in the outer crown. As of today, the patient is highly satisfied with

Fig.2 Panoramic X-ray photographs of three years and two months after the denture repair (2018.9.11)

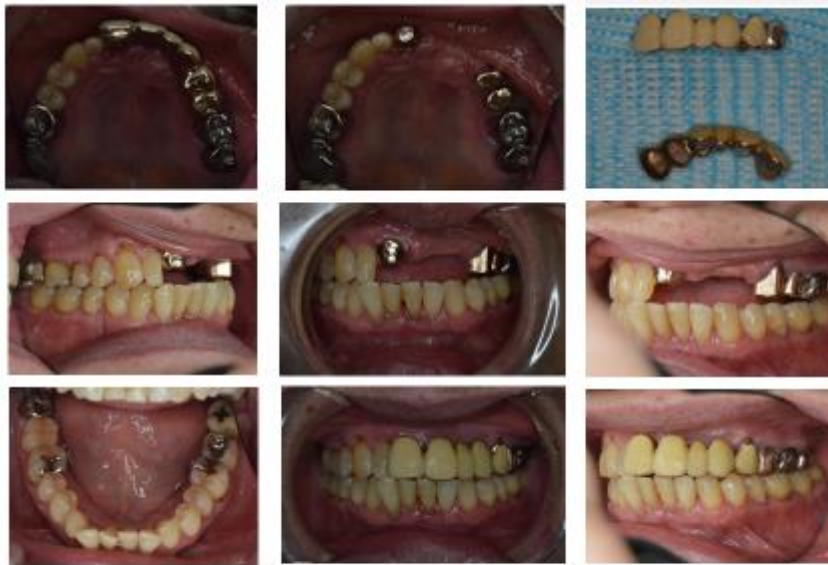
using the repaired denture (Fig.4).

Fig.4 Intraoral view and the denture taken three years and two months after the denture repair(2018.9.11)

The goal of prosthodontic treatment in this case was to make full use of existing dentures. In order to achieve this goal, the maxillary right central incisor was replaced with an MT crown instead of the inner crown, and the magnetic attachment was attached to the outer crown. Since the maxillary right central incisor tooth was originally a vital tooth, the outer crown was larger than the ideal size, so it was easy to secure the space for the magnet structure, which worked favorably at the time of manufacture. By applying a magnetic attachment to only one of three abutment teeth, the MT crown and inner crown were combined in one prosthetic device. However, as of now, there has been no detachment of the inner crown or fracture of the abutment teeth, and the periodontal tissue is also well maintained. Since the patient also uses it without discomfort, it is considered to have been a reasonable denture repair.
