## Progress report on the implant-assisted removable partial denture units (IRPD) using a new method for attaching magnetic assemblies

○Hiroaki Yamamoto , Masayuki Hideshima<sup>1</sup>

Tsuda Dental Clinic, Japan Institute for Advanced Dentistry <sup>1</sup>Dental Clinic for Sleep Disorders (Apnea and Snoring), Tokyo Medical & Dental University

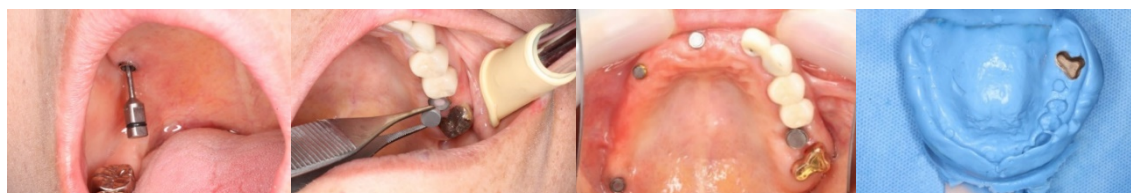
After intraorally fastening the completed abutment, which will serve as the keeper's receptacle (Fig.1). The keeper is fixed with Superbond™(Fig.2). After that, the internal crown of the cornus is placed (Fig.3) and a precise impression is taken to incorporate the internal crown (Fig.4). The keeper is currently attached to the abutment with cellophane tape to prevent it from falling off.

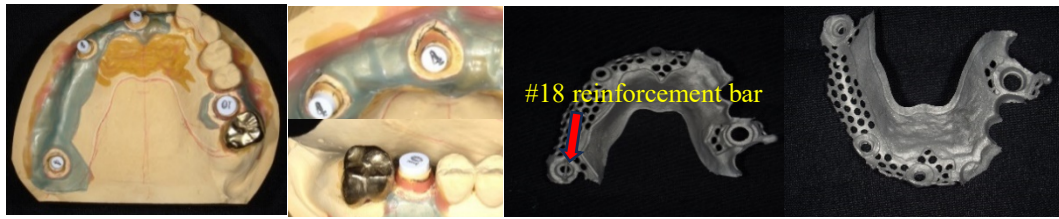
An external crown is fabricated as shown in the study model incorporating the inner crown of the conus, and the replica of MA is attached to the keeper (Fig.5). The undercut of the abutments with the replica are blocked out (Fig.6) and a refractory model is fabricated. After looking at the current 10-year case, we feel that metal touch around the abutment is very useful from view point of preventing the induction of peri-implantitis. The finished cast frame with metal housing (Fig.7.8). Since the thickness of the resin cannot be taken for #18, a reinforcement bar is given to the upper part of the housing (Fig.7). In addition, the bonding surface to the resin is blasted with Rocatec™ sand to reinforce the strength of the cast frame.

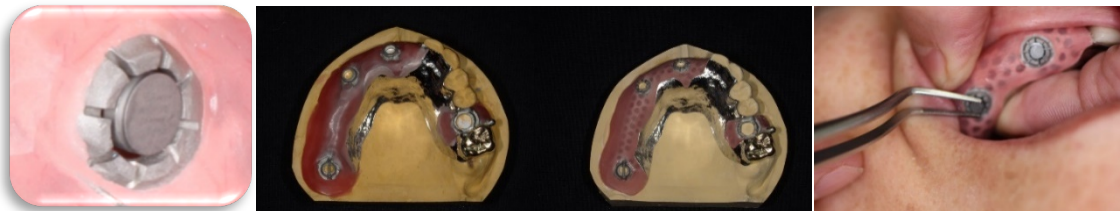
The housing should have a cutout as shown in the photo (Fig.9). The cast frame is returned to the study model with the MA replica removed, and after waxing the external crown of the conus and cast frame (Fig.10), the permanent foundation base is fabricated with poured-in-place polymerized resin. The photo (Fig.11) shows the completed permanent base restored to the duplicate model of which undercuts of the alveolar bone mucosa are removed. The permanent base is placed in the oral cavity with a trial fit of the internal crown, the MAs are attached (Fig.12), and they are fixed in the metal housing by immediate-curing resin (Fig.13).

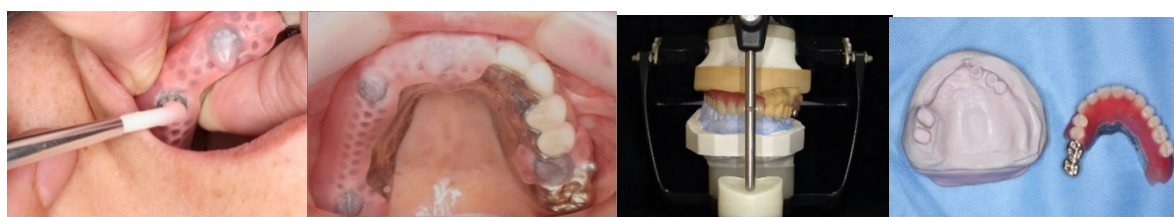
The permanent base is held in place for 10 minutes (Fig.14). And it is removed from the oral cavity. Looking at the area around the MA from the mucosa surface, there are areas where there is insufficient resin, so add resin with an ultra-fine brush, wipe off the excess, and re-test. After that, the occlusion is taken using the permanent base. The model is returned to the duplicate model that will be attached to the articulator, and the artificial teeth are placed. If there are residual teeth in the esthetic area, as in this case, it is necessary to return to the duplicate model of which undercuts of the alveolar bone mucosa is removed for placing of the artificial teeth. On the other hand, if the remaining teeth are not affected by the removal of the artificial teeth, as in the

case of the IOD and the case shown in the photo (Fig.16), it can be used laboratory silicone when the model is attached to the articulator. The denture was then trial-fitted, and the remaining wax portion was replaced with poured polymerized resin to complete the denture

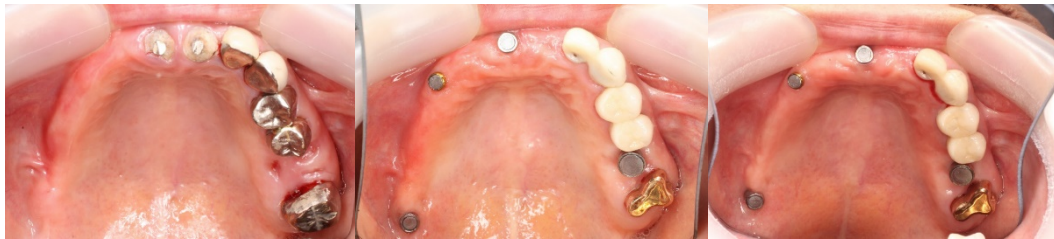
Fig.18 At the time of first visit

Fig.19 When wearing denture

Fig.20 At 7 years

of housing #18 is exposed (Fig.23). The condition of the remaining maxillary teeth has improved since the initial examination (Fig.17,20).

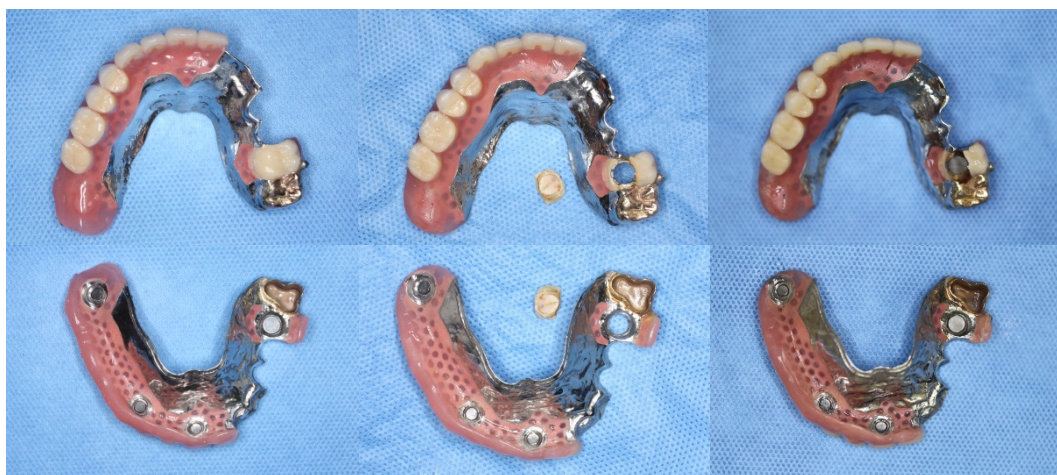
Fig.21 When wearing denture

Fig.22 At 4 years

Fig.23 At 7 years

This is the condition of this denture after 7 years. The resin and the artificial tooth that cover MA #26 have detached (Fig.22), and the denture has to be fixed with Superbond™. In addition, the boundary line between the primary and secondary resin in the median palatal area is becoming prominent, and the reinforcement bar

This time, we discuss the failure event in Case 1 as a problem specific to IRPD with magnetic attachments. The internal structure of the implant and abutment is shown on the right. The abutment can only be shortened up to the screw head position, and then the thickness of the keeper and MA are added and sealed with denture resin and an artificial tooth. The surgical solution to secure that resin thickness is to select an implant with the shortest height of abutment and to consider a deeper placement.

On the other hand, the prosthetic solution is to use the reinforcement bar used for #18 (Fig.7). However, the site where the reinforcement bar is used should be blocked out of the undercut up to the height of the MA. The use of a smaller radius magnet may also be effective.

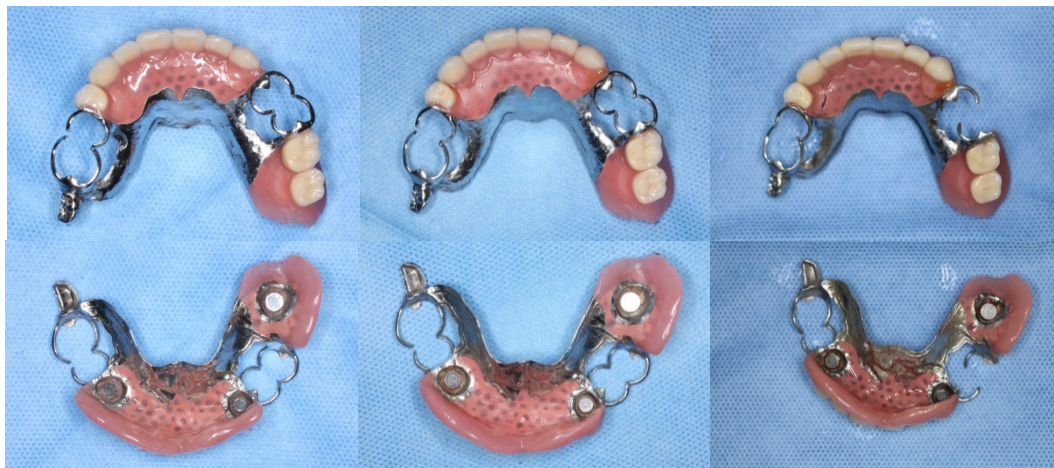
Fig.28 When wearing denture

Fig.29 At 4 years

Fig.30 At 7 years

The 2-armed hooks of #24 and #25 have been fractured (Fig.30), but they are being used as they are. Although tooth pulp of #15 and #24/25 have been extracted, the condition of the maxillary periodontal tissues is better than at the initial visit (fig25,27).

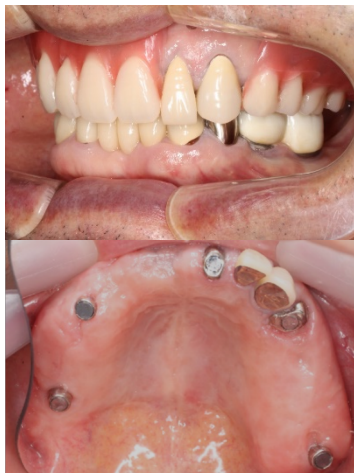
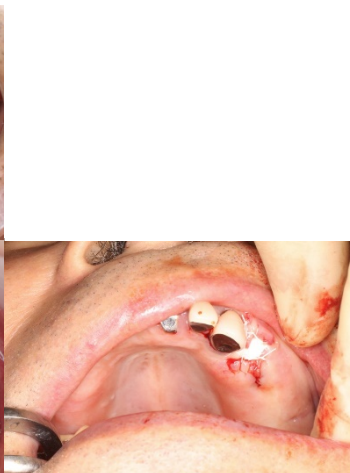
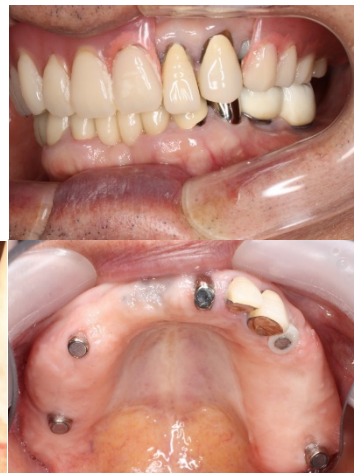
Fig.37 When wearing denture

Fig.38 When placing implant

Fig.39 keeper of implant abutment

Tooth #24, which was used as a keeper, was fractured due to an accident and was replaced with an implant. In order to create the abutment according to the position of the metal housing and MA of the denture, an impression was taken of the denture inner surface and mucosa surface (Fig.34), the impression material was returned to the mucosa surface, initial drilling was done from the MA position indicated by the indicator line (Fig.35). And the implant position was determined after it was confirmed that there was sufficient depth for the height of abutment, After the second surgery, a temporary abutment was fabricated using immediate curing resin, an impression of the abutment was taken with a digital scanner, and a CAD/CAM was used to smooth the submucosal shape indicated by the indicator line and fabricate a zirconia abutment (Fig.36). Intraoral photographs at the time of denture placement, implant placement, and replacement of the implant-supported zirconia abutment with a keeper (Fig.37,38,39).
