# A basic study on the fitness of a zirconia keeper coping fabricated by CAM system

H. HAMASAKA, M. SONE, Y. OKAWA, S. SOMEKAWA, M. MASUDA, A. MATUI, Y. TOYOTA, F. OKUTSU, T. MATSUKAWA, K. OKAMOTO and S. OHKAWA

Division of Removable Prosthodontics, Department of Restorative and Biomaterials Sciences, Meikai University School of Dentistry

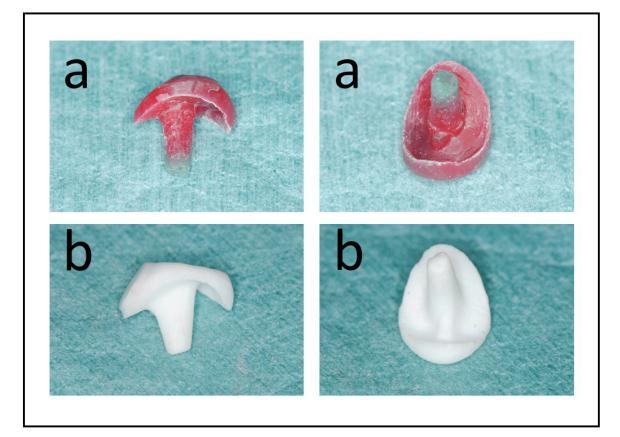
Fig.1 Keeper coping specimens in this study (a: Wax pattern b: Zirconia keeper coping)

Fig.1 shows the wax pattern used for scanning and the zirconia keeper coping fabricated by this CAM system.

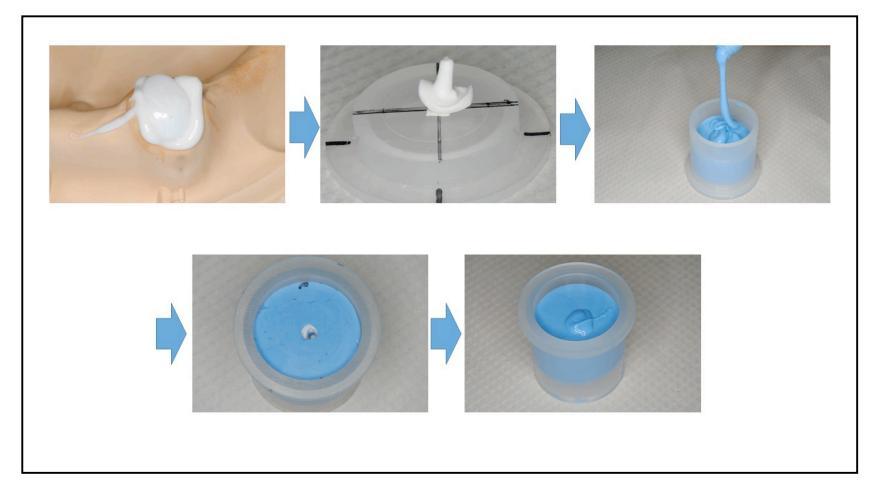
Fig.3 Fabrication procedure of specimens (Cement-replica technique)

*Methods (Cement-replica technique)*: The fitting accuracy was evaluated using a cement-replica technique. Each keeper coping was placed in the master die with a white silicone material (FIT CHECKER ADVANCED, GC). After curing a white silicone material, the keeper coping with a white silicone material is removed from the master die. Then, the keeper coping with it was embedded in a blue silicone material (EXAMIXFINE Regular Type, GC). The keeper coping was demounted from the cured silicone material, and a blue silicone material filled in the space (Fig.3).

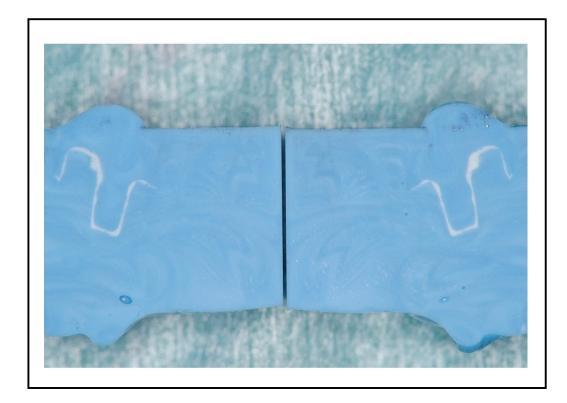
Fig.4 Section of silicone replica specimen in the buccolingual direction

*Determination of fitting accuracy*: Each silicone replica specimens were sectioned in the buccolingual direction through the center of the coronal root (Fig.4). The measuring points of the white silicone layers are shown in Fig.5. The maximum value was picked up from the range of each part.

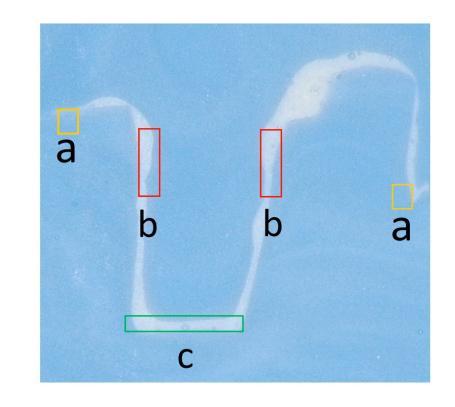
Fig.5 Measuring points (a: Finish line of coping b: Interface between coping and post c: Tip of post)

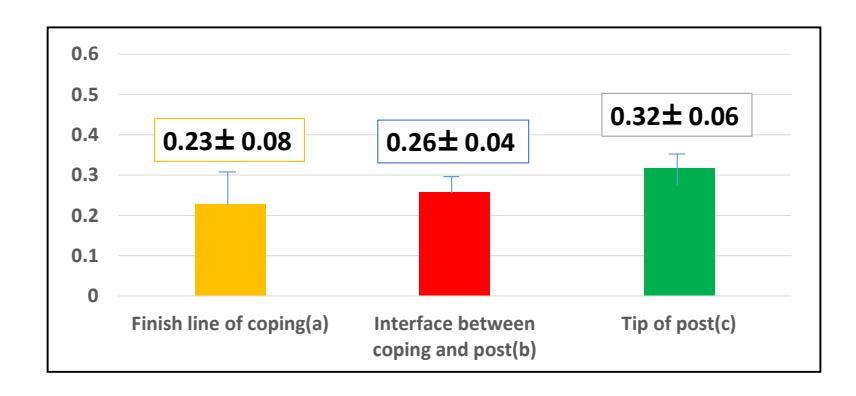
Fig. 6 The mean thicknesses of the white silicone layers at 3 measuring points

The mean thicknesses of the white silicone layers, namely the mean fitting gaps, were  $0.23 \pm 0.08$  mm at the finish line,  $0.26 \pm 0.04$  mm at the interface between the coping and post, and  $0.32 \pm 0.06$  mm at the tip of the post (Fig. 6). There was no significant difference in the mean thicknesses of the white silicone layers between 3 measuring points by one way ANOVA and Tukey–Kramer method (p<0.05).
